**LAKE WAUKEWAN DAM  
NH 00306**

**PHASE I INSPECTION REPORT  
NATIONAL DAM INSPECTION PROGRAM**

**OCTOBER 1978**

Name of Dam: Lake Waukegan Dam, I.D. NH 00306  
State Located: New Hampshire  
County Located: Belknap  
Town Located: Meredith  
Stream: Man made outlet between Lake Waukegan and  
Lake Winnepesaukee  
Date of Inspection: June 6, 1978

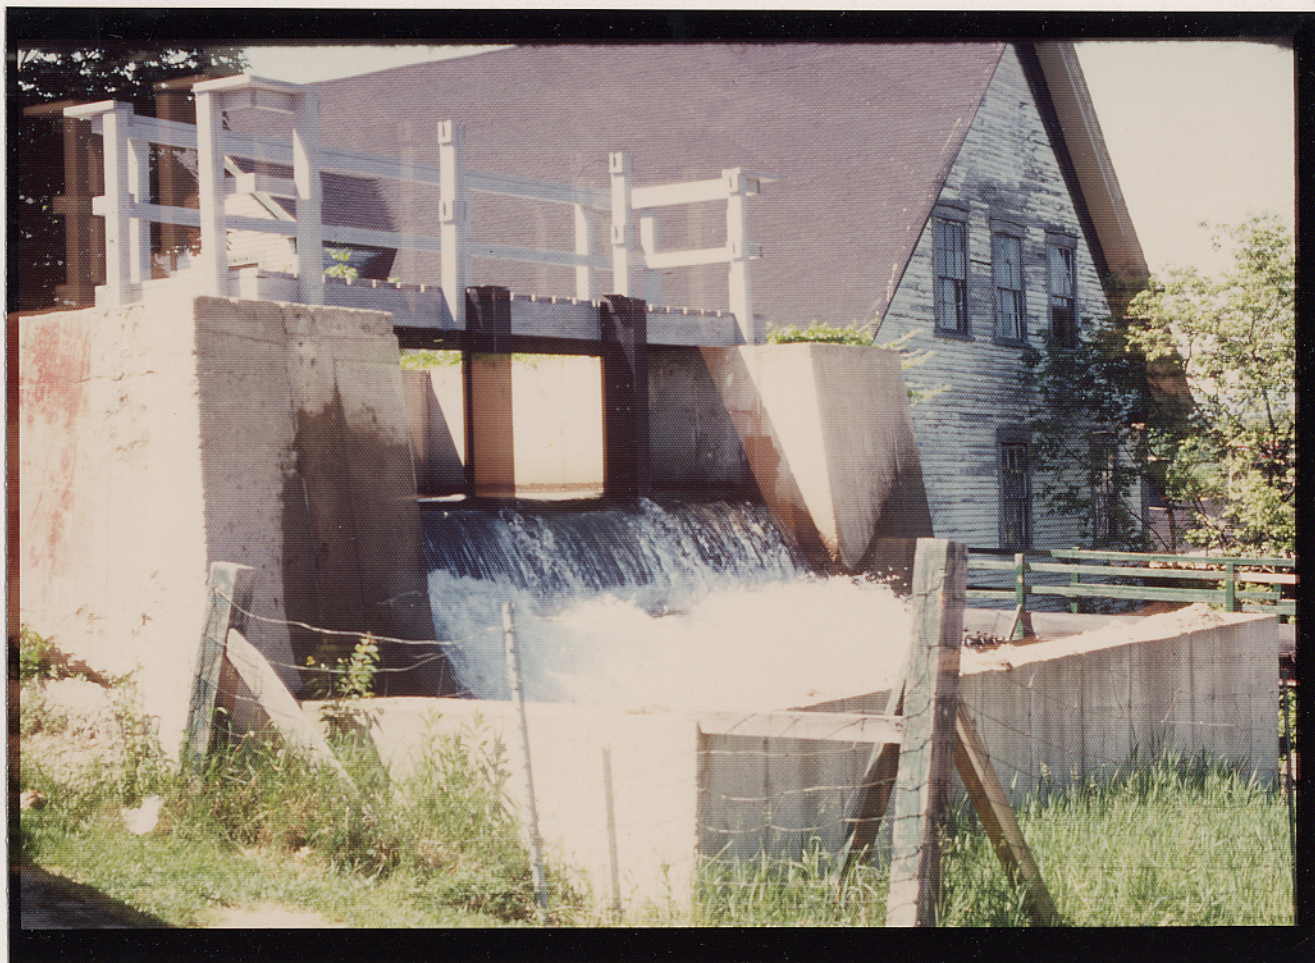
L A K E   W A U K E W A N   D A M

View of the surge and overflow structure in the Amatex Corporation parking area

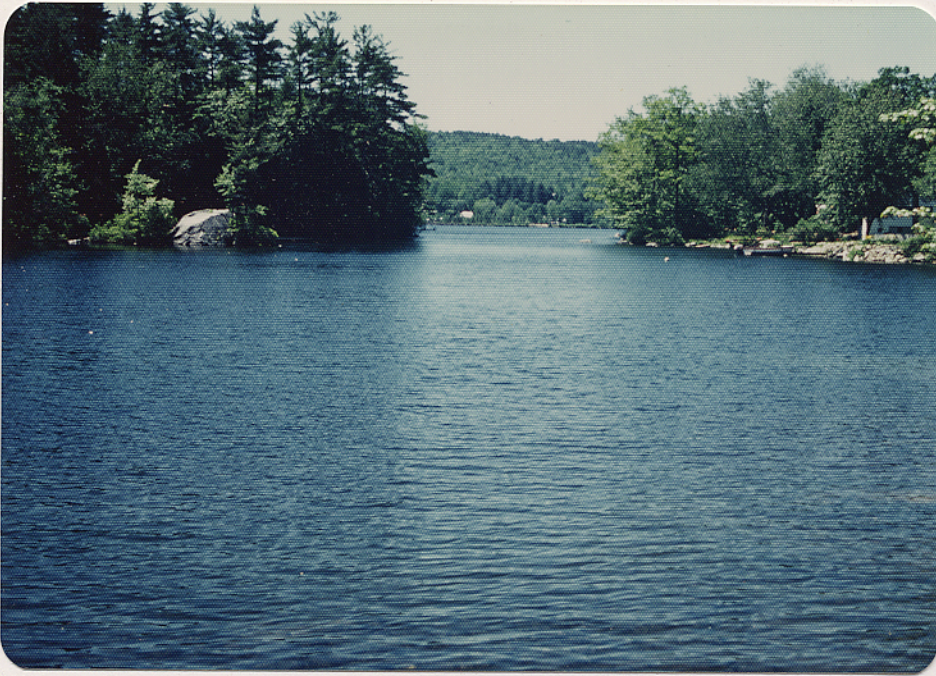
Photo 1 - View of Lake Waukewan from the head of the inlet canal.

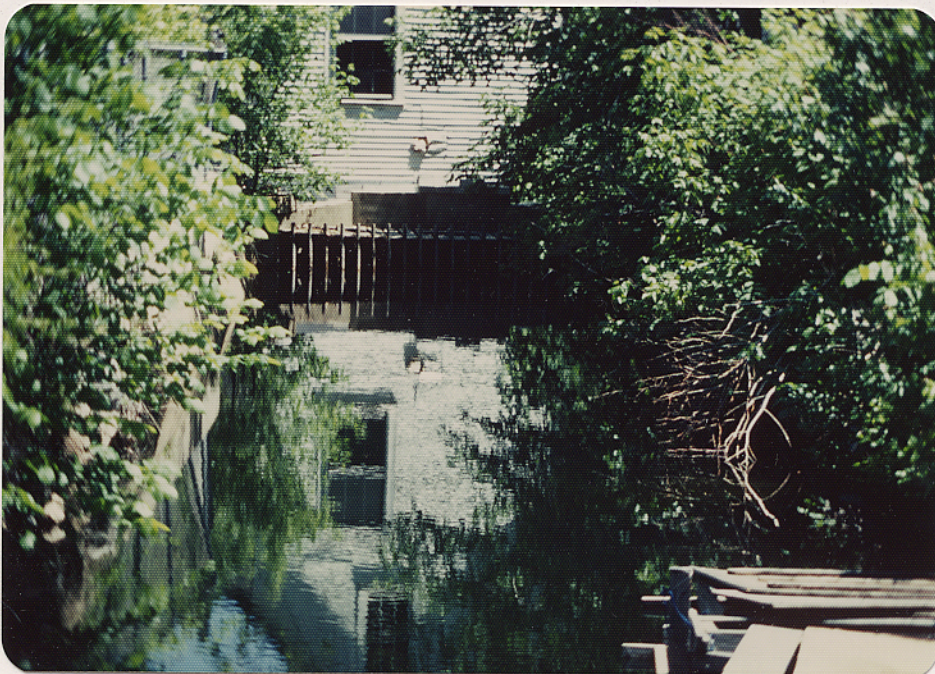
Photo 2 - End of the intake canal west of Main Street. The trash rack guarding the inlet of the 6 ft. x 6 ft. intake conduit passes under the building in the background and under Main Street, fronting on the building's other side.

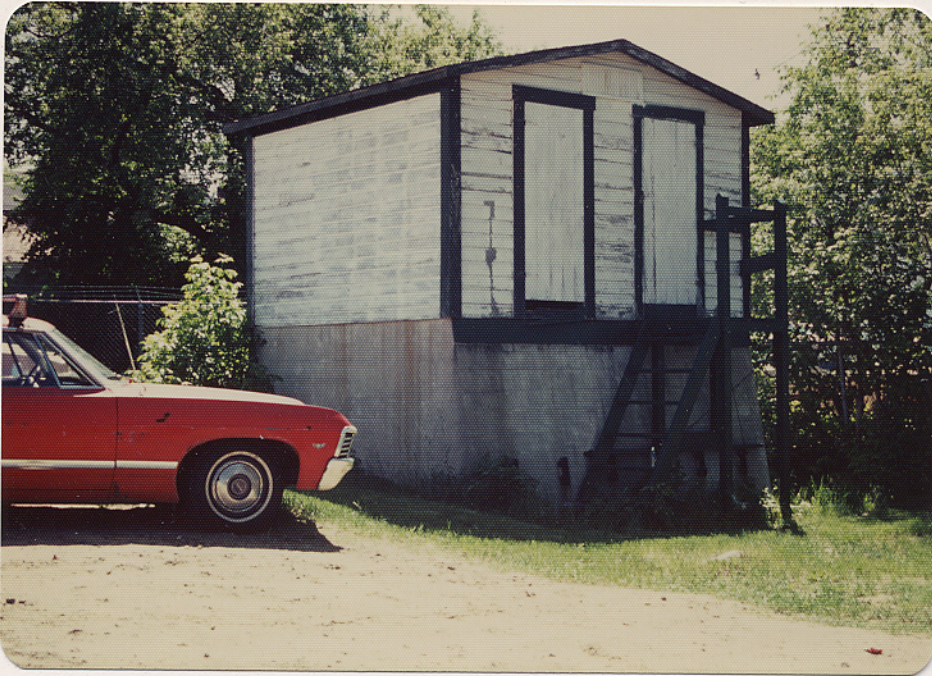
The gate house walls are of reinforced concrete construction. No leakage water or wet ground conditions were observed at the gate house structure. The gate house superstructure was of wood construction with siding and has a conventional roof covered with asphaltic sheet roofing material. The gate house was in acceptable condition.

Photo 3 - Gate house astride the 6-ft. diameter penstock. The gate inside is of timber construction, and can block off water for downstream maintenance.

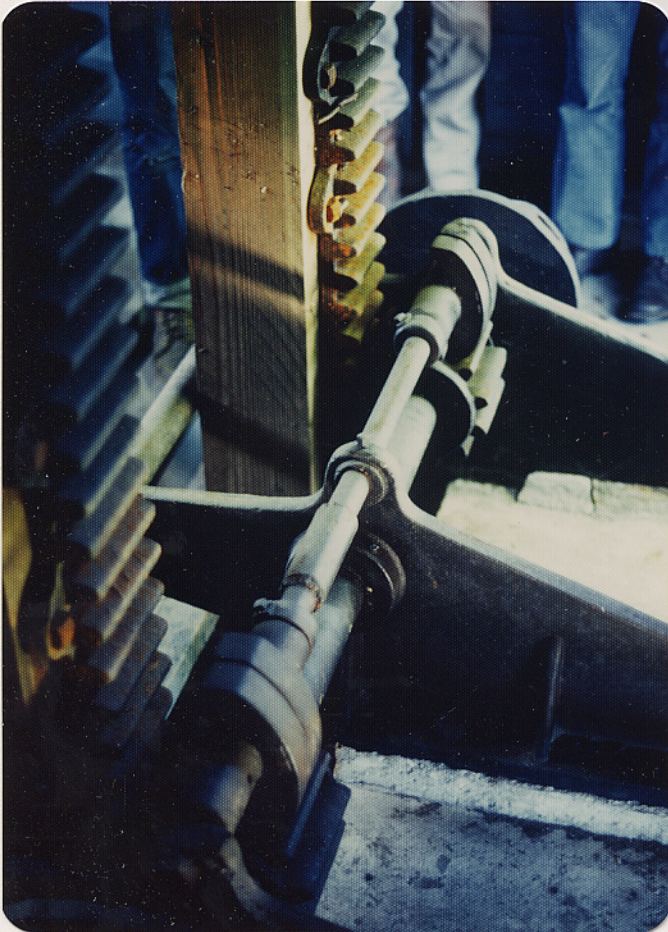
There is a one-foot diameter shear gate installed on the upstream face of the sluice gate. This shear gate is used to flood the downstream portion of the penstock pipe leading to the stop log structure after dewatering for maintenance. In this manner, the differential head across the sluice gate is eliminated and the effort required to raise the gate is reduced. The gate appeared to be in satisfactory operating condition, having been rebuilt in 1976.

Photo 4 - View of the double stem timber sluice gate lifting mechanism.

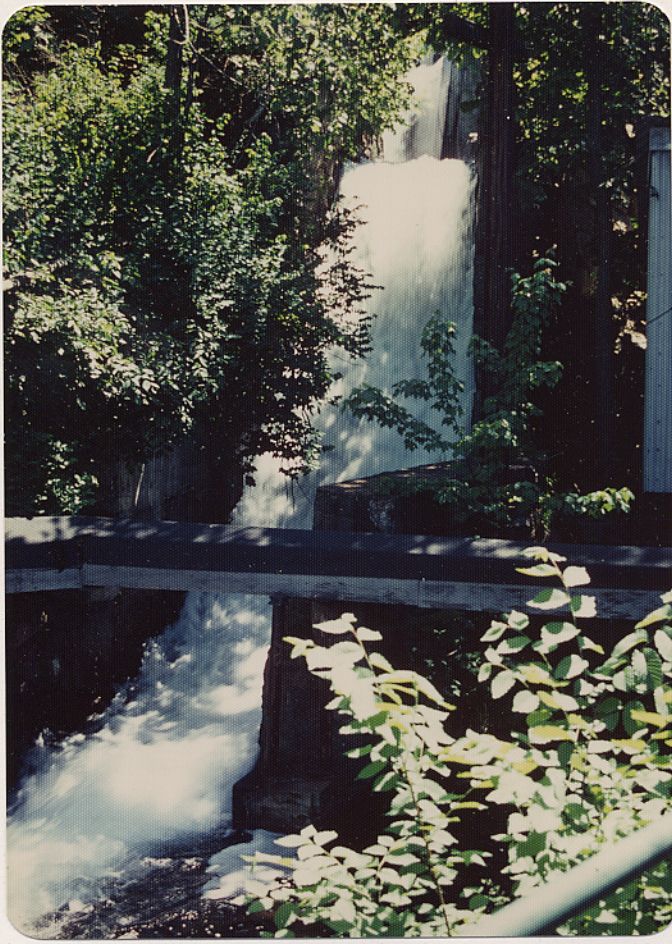
The entire chute channel and walls are in acceptable condition; however, the hydraulic performance during high flow conditions cannot be evaluated due to lack of configuration data.

Photo 5 - The chute channel downstream of the surge and overflow structure (refer to overview photo). The total drop is about 35 feet.

Reevaluate the hydraulic capacity of the outlet chute channel at the Spillway Design Flood (SDF) discharge conditions and reassess the possibility of undermining this part of waterway and the adjacent surge and overflow structure at SDF discharges.

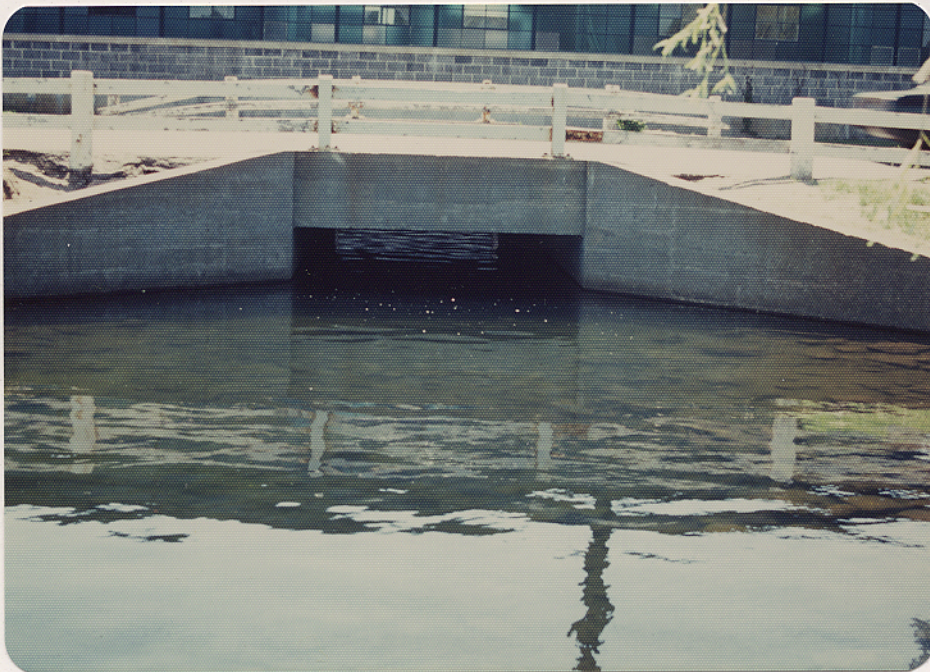
Photo 6 - View of the outlet to Lake Winnepesaukee. The culvert runs under U.S. Route 3 and the Amatex Corporation mill building in the background.

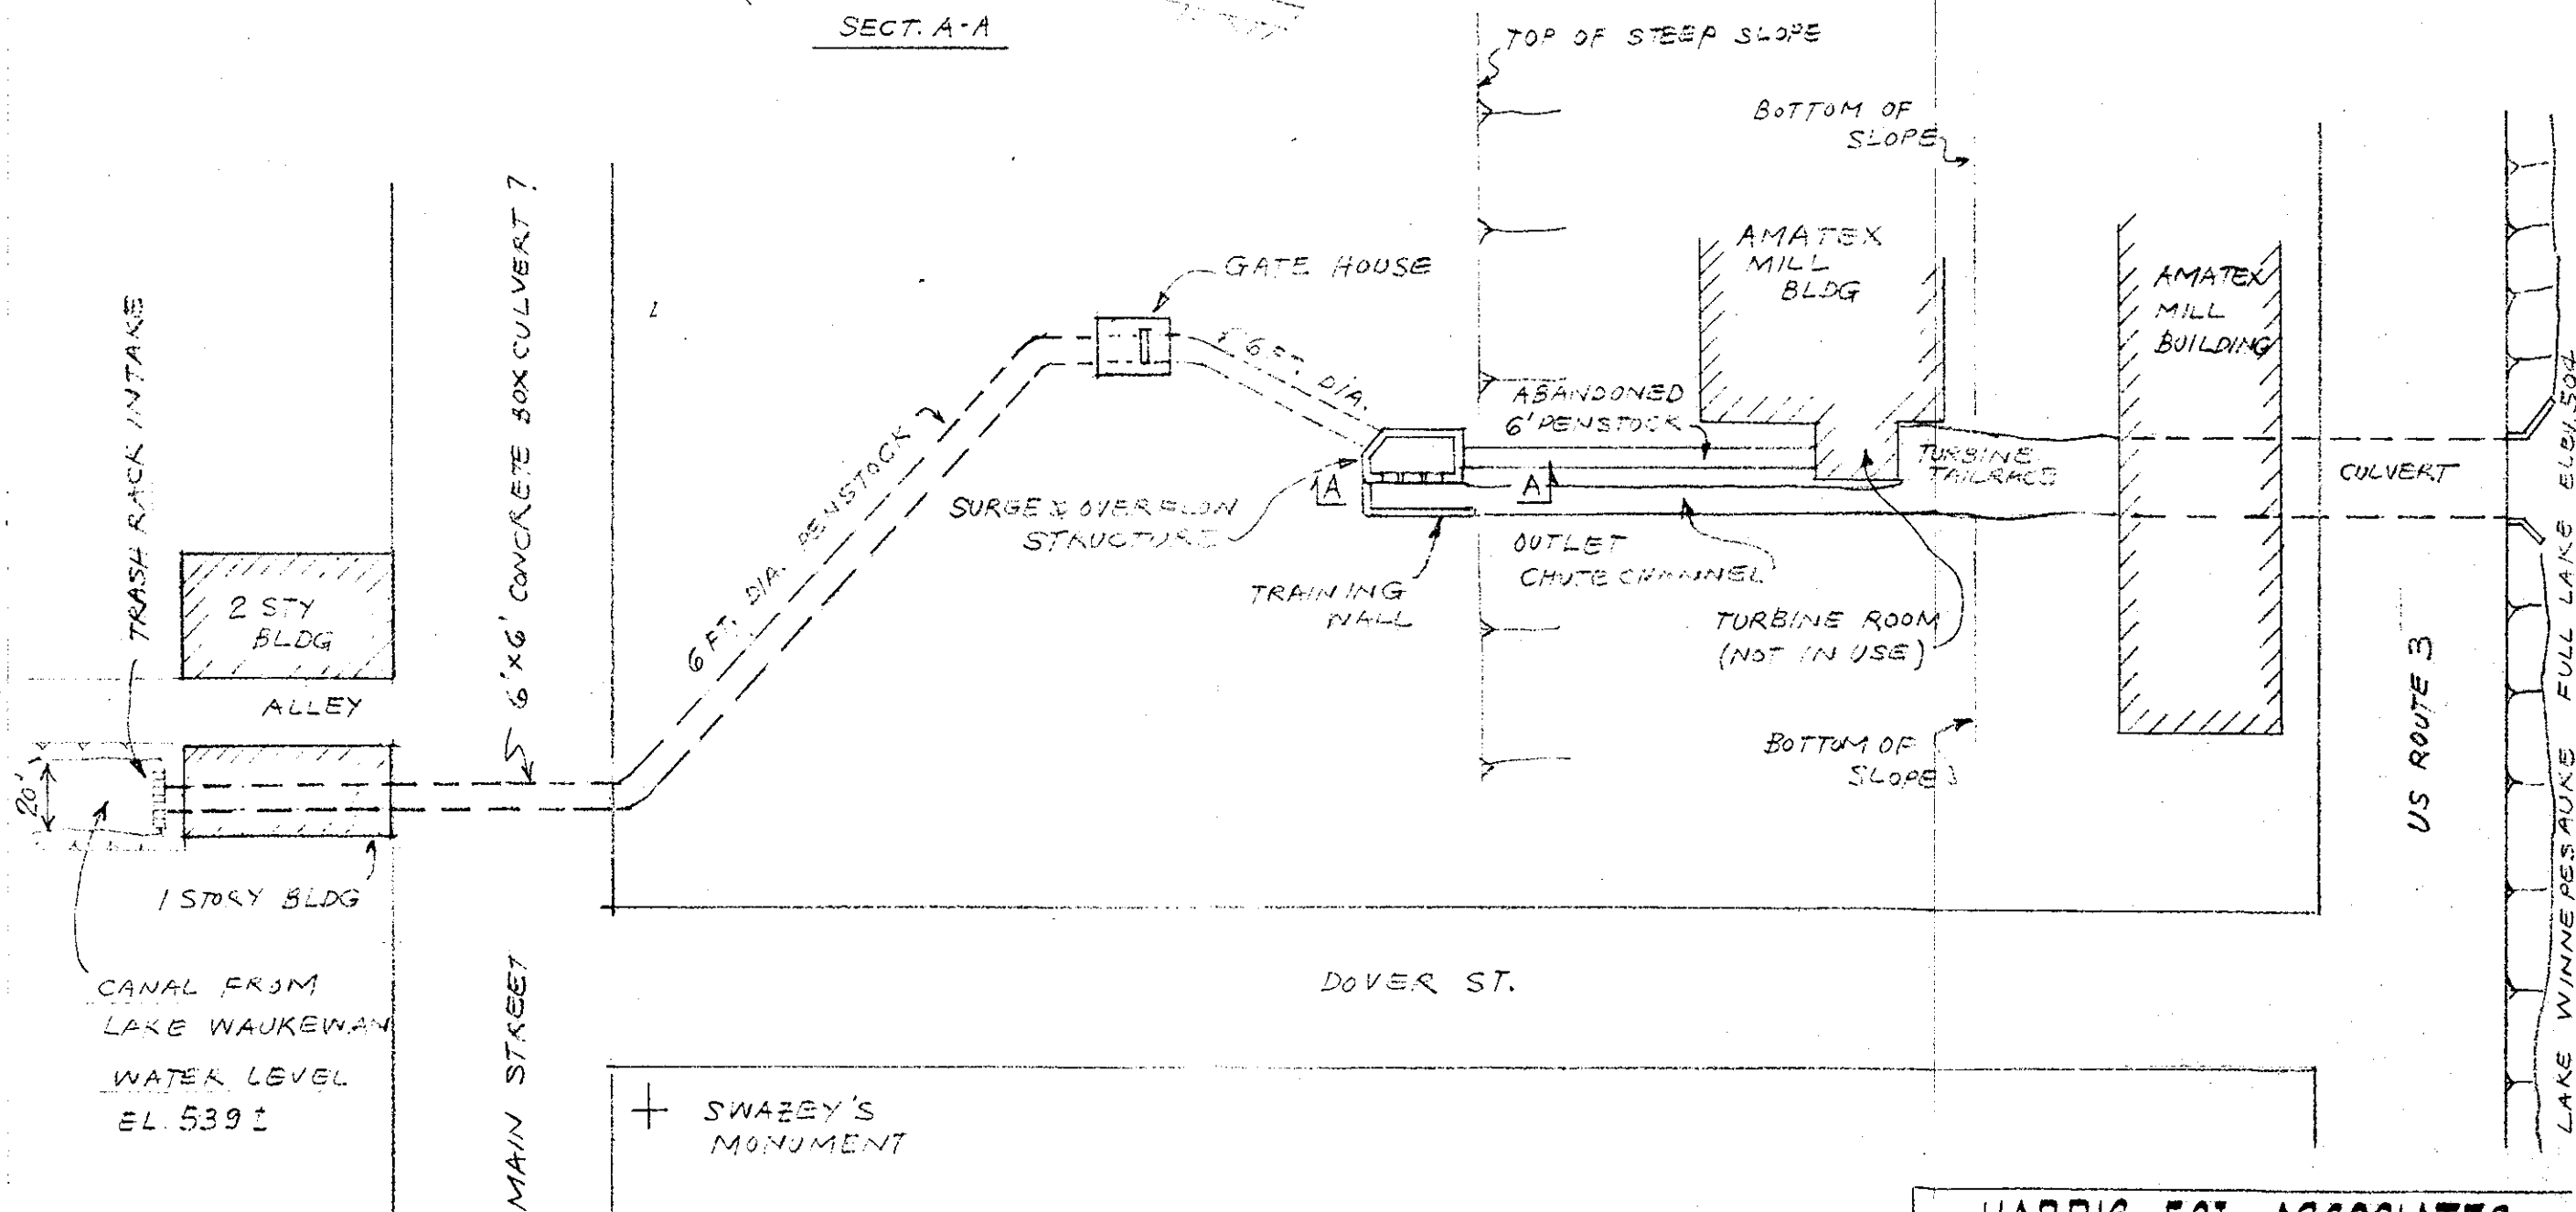
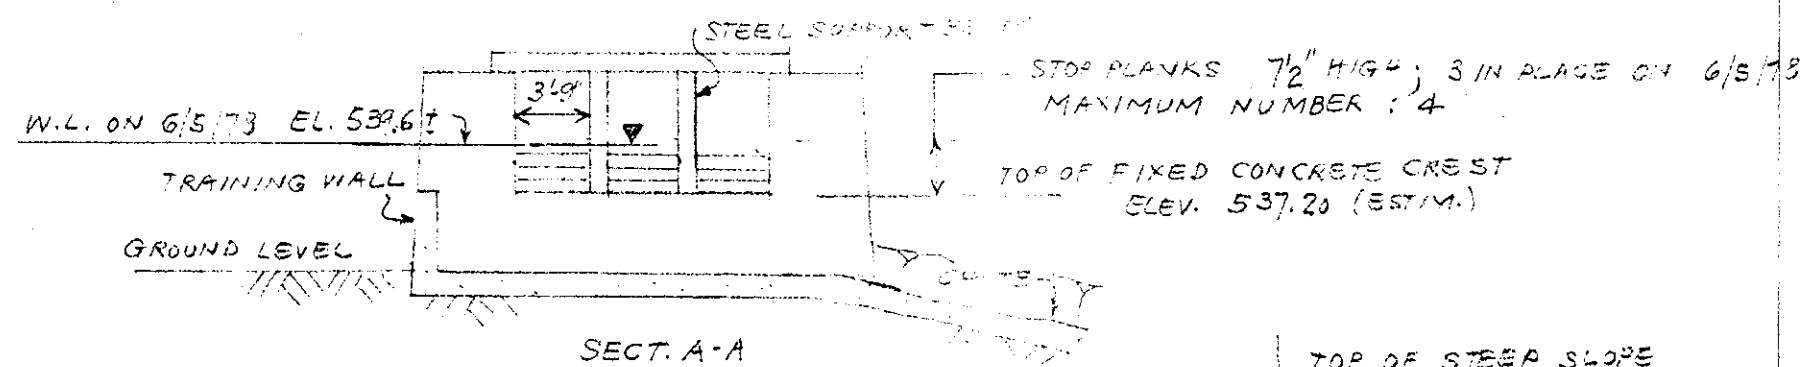
HARRIS-ECI ASSOCIATES	
LAKE WAUKEGAN DAM	DWG. 2
FIELD INSPECTION SKETCH

There are no plans for any part of this facility, whether for parts built originally in 1904 or sections reconstructed in 1976. A reconnaissance sketch of the schematic layout of the facility is shown on Drawing 2. There is no design information available on the subsurface conditions along the outlet water waterway.
